DRAINAGE AND RETENTION OF WATER BY CLADDING SYSTEMS

ABSTRACT

This laboratory study investigated the drainage, retention and isothermal drying of various wall cladding systems to determine behavioral characteristics and factors affecting their ability to dry.

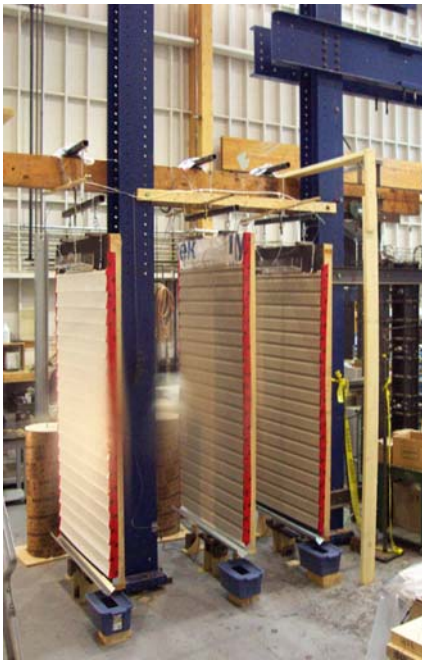
Figure 2 Overview of test set-up for weighing test walls during drainage/drying testing.

The drainage set-up was composed of three weight-balancing systems to accurately measure the weight of water added and retained in each test wall during the wetting/drying test. This allowed three 1.22 m x 2.44 m (4ft x 8ft) wall systems to be evaluated at essentially the same time.

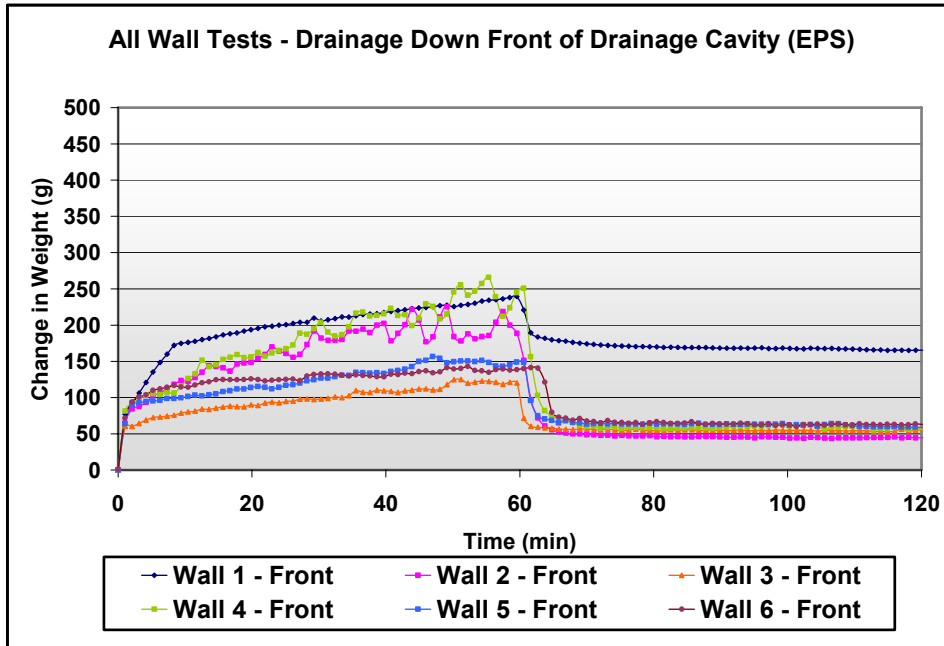
Figure 3 Composite plot of all EIFS drainage tests where water was trickled down the **FRONT** of the drainage cavity (down the back of the EPS).

to be delivered to specific surfaces at the point of entry into the drainage cavity. The composite drainage plots for Front and Back wetting are provided in Figures 3 and 4 for the 2-hr wetting/drainage period, and an example of combined 2-hr and 48-hr test duration is provided in Figure 5.

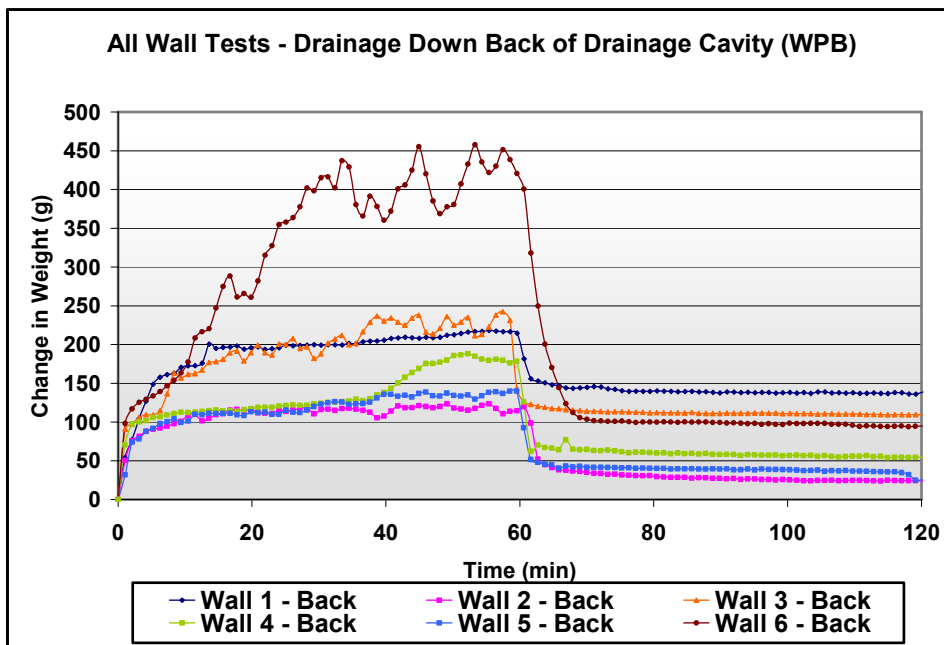
Figure 4 Composite plot of all EIFS drainage tests where water was trickled down the **BACK** of the drainage cavity (against the WPB)

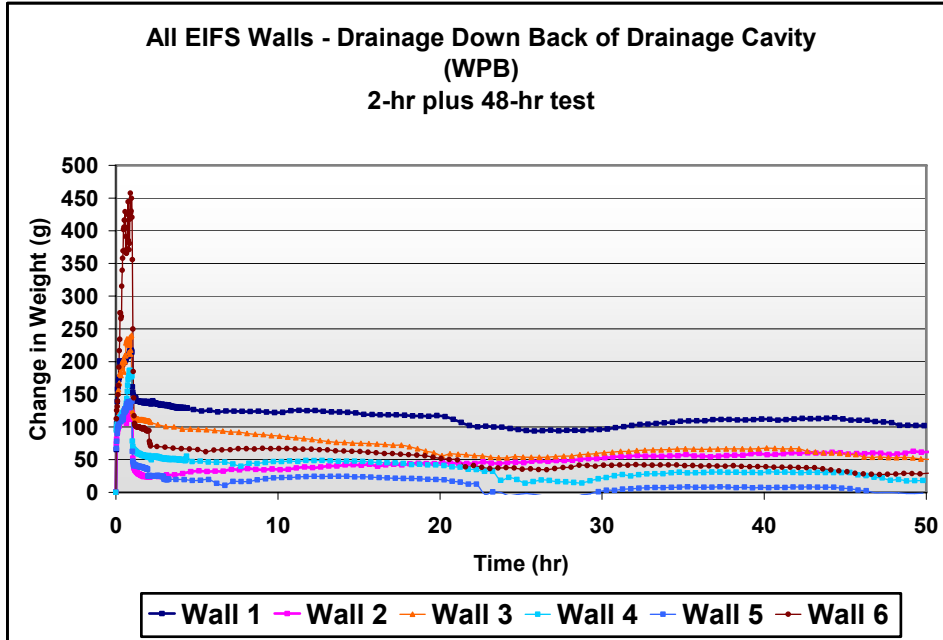
Figure 5 Composite plot of all EIFS drainage tests including 48-hr drying where water was trickled down the BACK of the drainage cavity (against the WPB).

From these profiles and from discussion in the previous section, it appears that test Wall 1-Front in Figure 5 experienced build-up of water in some of the EPS joints, based on the linear accumulation observed. Despite this, the subsequent drying rates were similar for all walls. Wall 2 and Wall 5, both having a relatively open starter panel at the bottom instead of a starter track, retained the least water. Additional comments and findings concerning these tests follow.

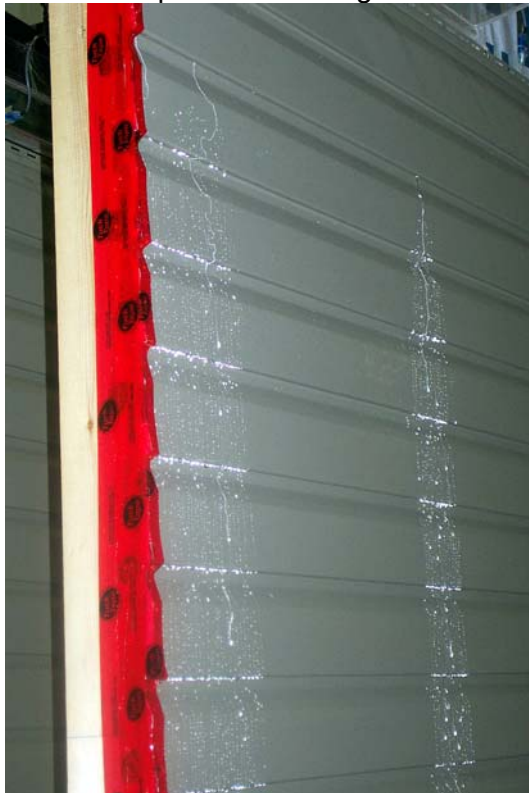
Figure 6 Example of face drainage from drain holes in vinyl siding (Profile #2)

On the other hand, Walls 2 and 3 (utilizing vinyl siding having Profile #2 with SPBO and building paper WRB membranes) demonstrated less extensive moisture loss by edge leakage. The profile of this siding simulated a different type of wood siding as shown in Figure 1. Water draining from these drainage holes was retained along that surface and drained down for collection by the gutter. An example of drainage down this profile type is shown in Figure 6.

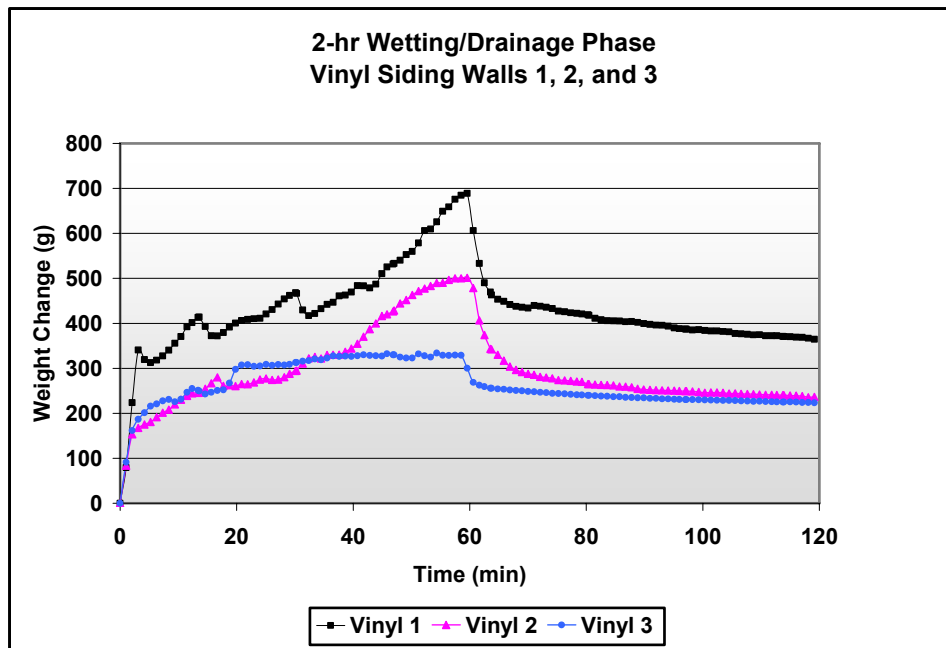
Figure 7 Composite plot of drainage tests on three vinyl clad walls for the 2-hr wetting/drainage period.

Composite drainage plots of all three test walls are shown in Figure 7.

The three plots in Figure 7 are instructive in revealing how water was retained during wetting. This opinion is based on observations during the tests and the shape of the resulting plots. Wall V1 experienced the most retention and leakage, leakage that involved wetting of the wood framing and hence storage. The sharp increase in weight to the end of the wetting phase of the curve implies that more water would have been retained if the wetting had been allowed to continue, perhaps by more absorption into the wood framing.

To a lesser degree, this also happened for wall V2 which had a different profile. The retention at this stage seems largely dependent on the degree of failure to hold water within the siding space to be drained through the holes provided. Wall V3, on the other hand, experienced little extraneous leakage and reached a near plateau of retention in 20 minutes, so the head of water attained remained sufficient to allow the water to escape as rapidly as it was supplied to the wall.

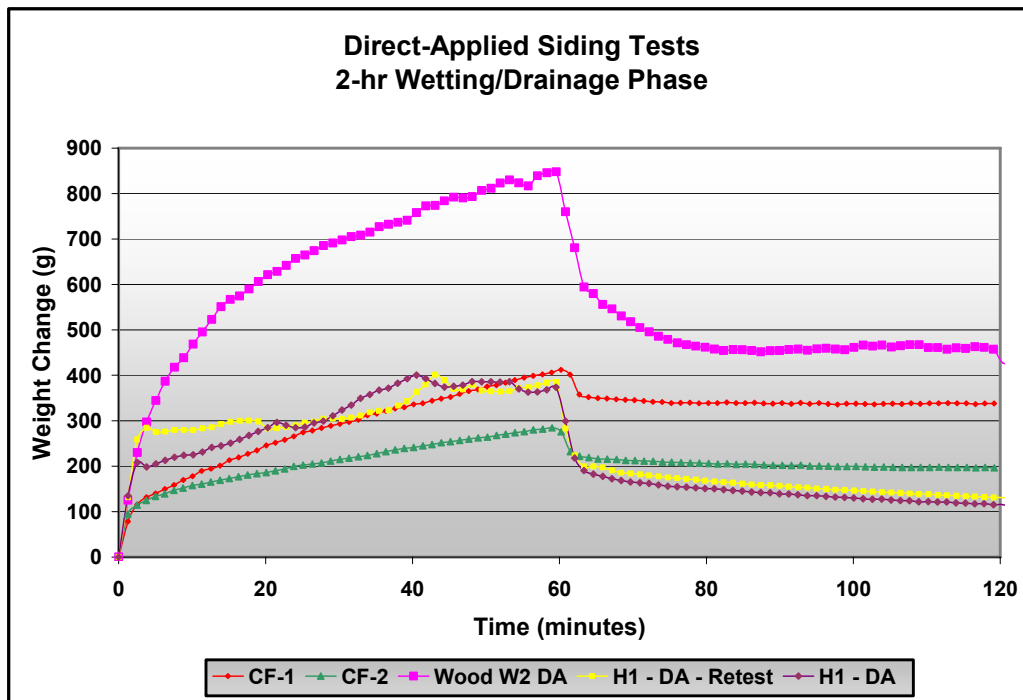
Figure 8 Composite plot of weight changes during the wetting/drainage phase for all walls with siding that was applied directly to the basic wall.

Composite drainage plots of all direct-applied sidings are provided in Figure 8. In all cases a SBPO weather resistant barrier was employed. Also included in this comparison is a retest of one wall.

Quite apart from the magnitude and shape of the curves plotted, it was commonly observed that direct-applied siding did not appear to allow a significant amount of water to flow down behind to lower siding courses. Most of the water escaped through the first joint encountered by the water which then flowed over the face of the siding below. Some retention of water in the joint profiles occurred, but that level of detail could not be investigated in this study.

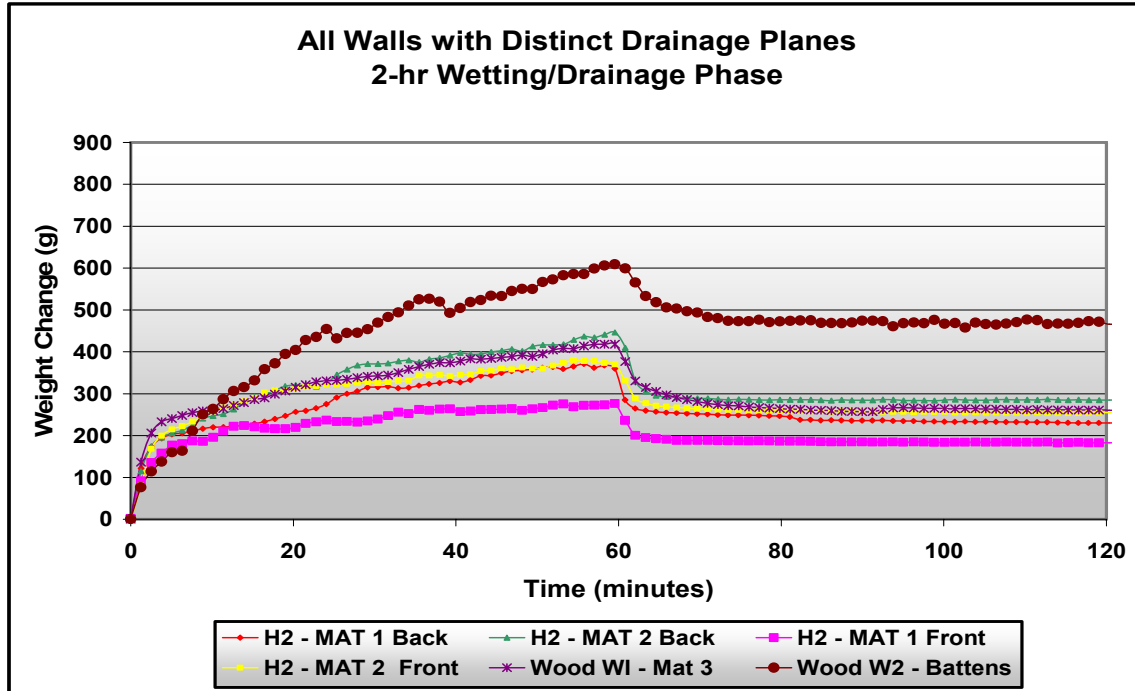
Figure 9 Composite plot of weight changes during the 2-hr wetting/drainage phase period for all walls with siding that was applied over some form of drainage matrix or batten strips.

All siding installed over drainage cavities performed as expected. Most of the water that trickled in at the top of the drainage space flowed within that space to the bottom where it was collected by the sloped gutters. The composite plots for these test walls are provided in Figures 9 for the first 2 hours of test.

- Contrary to expectations, the system with the largest initial retention was for the wood siding profile W2 installed on wood furring strips (19 mm x about 64 mm). The effect of the wood siding profile was immaterial in this case because the trickling of water was done to the back side of the drainage space. At least one trickle of water deposited directly on top of each furring strip and this water was absorbed quickly into the end grain. Despite the higher retention at these locations, this wall dried more quickly than other siding on drainage mats because of the larger drainage space and because the exposed ends of the furring strips were at the top of the drainage cavity.
